DEPARTMENT OF TRANSPORTATION

Contract #: 04-0120F4Cty: SF/ALA Rte: 80 PM: 13.2/13.9File #: 69.28**WELDING INSPECTION REPORT****Resident Engineer:**Siegenthaler, Peter**Address:** 333 Burma Road**City:** Oakland, CA 94607**Report No:** WIR-023507**Date Inspected:** 20-Apr-2011**Project Name:** SAS Superstructure**OSM Arrival Time:** 1500**Prime Contractor:** American Bridge/Fluor Enterprises, a JV**OSM Departure Time:** 300**Contractor:** Zhenhua Port Machinery Company, Ltd (ZPMC), Changxing Island **Location:** Shanghai, China

Bridge No: 34-0006**Component:** OBG Segment Assembly**Summary of Items Observed:**

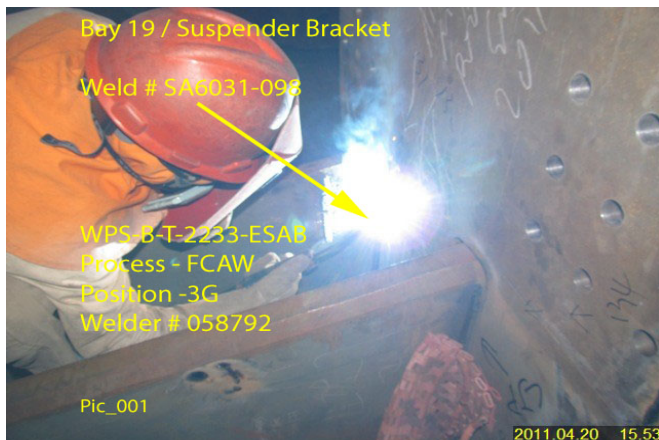
Bay 19 / Suspender Bracket

Flux Core Arc Welding (FCAW) in the 3G position of weld # SA6031-098. The welder is identified as 058792. Quality Control (QC) is identified as Guo Xing Hui. The welding variables recorded by QC appeared to comply with WPS- B-T-2133-ESAB. See attached photograph Pic_001.
